# Water Quality -South Shore-

# Indicators of fecal contamination

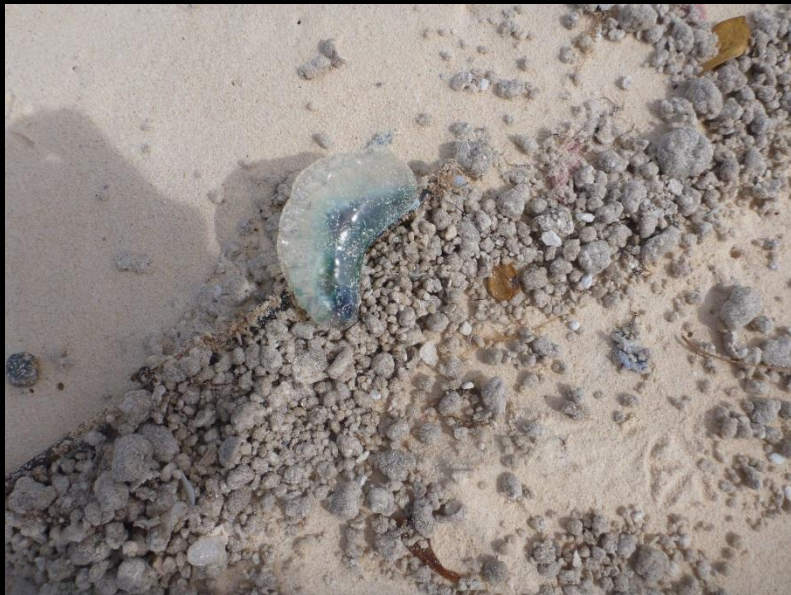
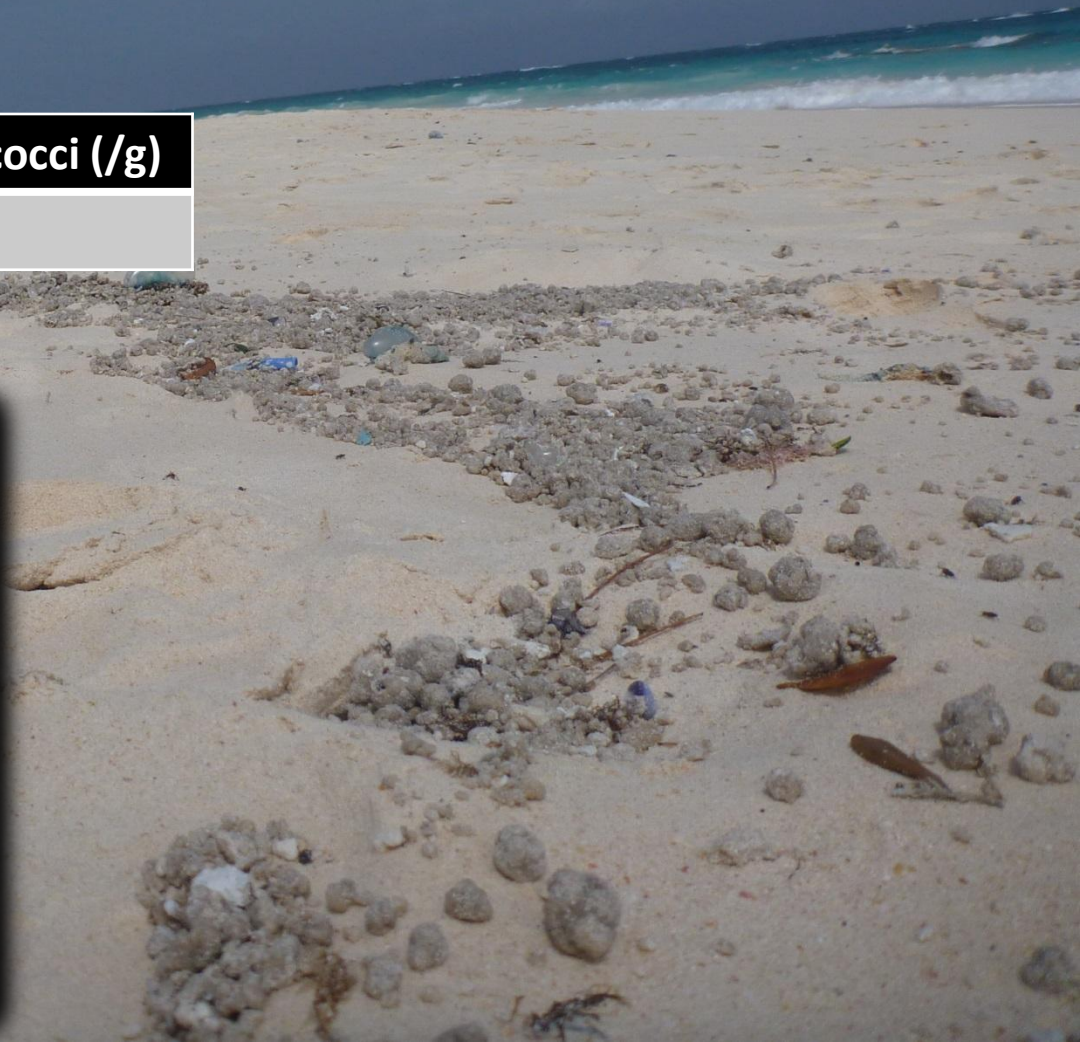
## Elbow beach

Sewage Balls	Ecoli (/g)	Enterococci (/g)
17 April 2013	24 000	400

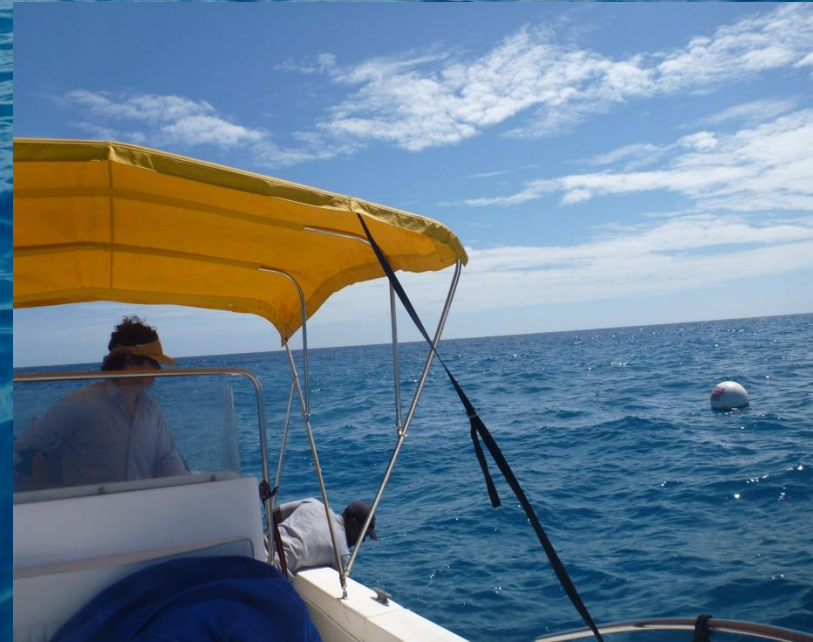
Grape Bay beach

# Offshore sampling 18, 26<sup>th</sup> April 2013

Sites	Thur, 18April Enterococci (CFU/100mL)	Fri, 26April Enterococci (CFU/100mL)	USEPA Single Sample Limit*
Hungry Bay Outfall	2500	2300	104 CFU/100mL
Hungry Bay 16m depth		140	
Off shore Grape Bay	105	32	
Off shore Elbow Beach (over shipwreck)	143	35	
Off shore Southland	137	<1	
Off shore Horseshoe Bay	161	8
