# INCIDENT REPORT

The following is a incident report concerning a Dark Haze from Mediwaste Medical waste stack. The report has been divided into five sections as follows:

Mediwaste main stack for medical waste incineration (See below)

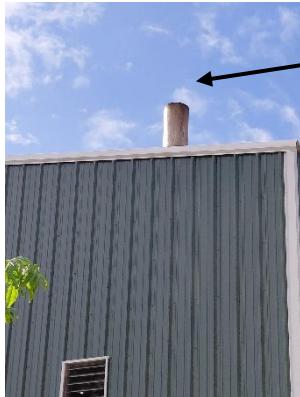
Dark colored haze was spewing from the stack during every blowdown sequence in the pollution control system (PCS) which lasted about 2 to 3 mins. The blowdown sequence occurs every 7 mins.

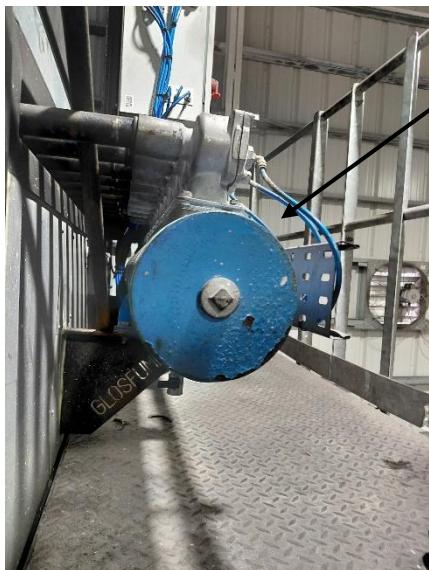
Main Manifold for the blowdown high pressure air supplies

The manifold ( See Photo below) supplying the high-pressure air for the PCS blowdown had moved about 5° clockwise therefore a high frequency sound would occur during blowdown and the high pressure air didn't reach the interior of the G3-1.25m Ceramic Elements and due to insufficient air flow during the blowdown the ash on the exterior section of the G3-1.25m Ceramic Elements was not removed. The ash accumulated on the exterior of the elements triggered a failure of the elements and the gaskets holding the elements.

We will conduct full inspections of the PCS every three weeks of the blowdown manifold, Element gaskets and Elements. If there are any indication of a dark Haze excepting from the stack we will stop burning and investigate.

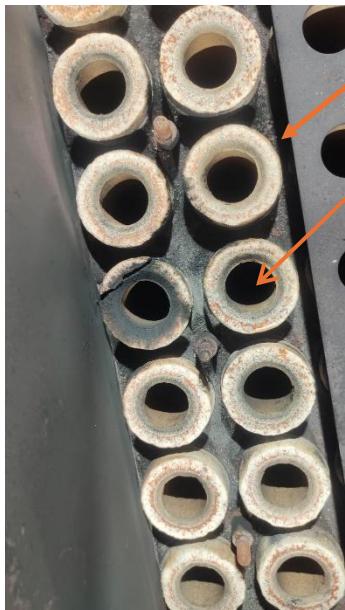
The PCS took 24 hours to cool down from 375°C to a safe temperature for the staff to perform an inspection of the PCS. During our inspection of the PCS, we found 18 of the (Candles) were damaged and required replacement. 56 Ceramic gaskets holding the candles in place were also damaged and required replacement.

Dark haze will be seen from the medical waste stack if 4 or more G3-1.25m Ceramic Elements are damaged.

We replaced all Element gaskets (440) with new gaskets, and we replaced 25 of the elements.

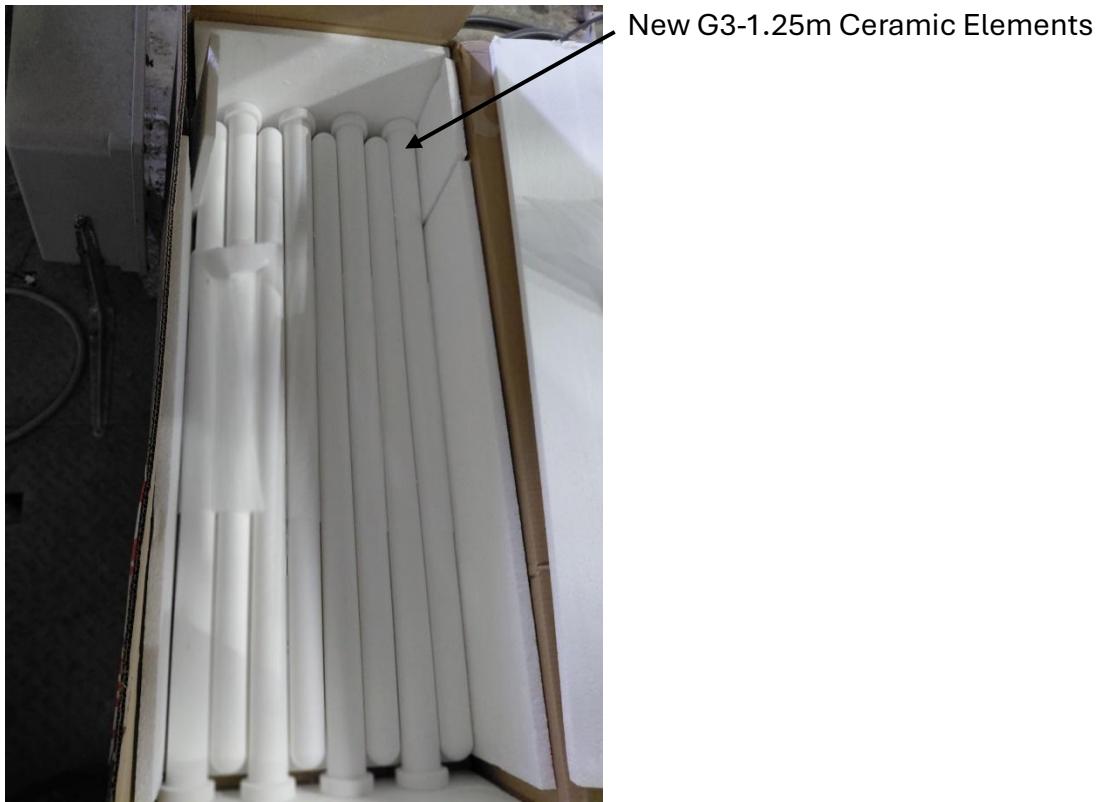
Internal hollow section of the G3-1.25m Ceramic Elements. The blowdown high pressure airflow flows through the hollow area.
